## Good Shepherd Center Replanting Proposal

Date: 11/3/2020  
To: Landmarks Preservation Board  
From: Tara Macdonald, Lead Gardener for Historic Seattle, PDA – Good Shepherd Center  
Subject: Hazard tree replacement proposal for Good Shepherd Center  
Address: 4649 Sunnyside Ave N, Seattle, WA 98103  
Parcel #: 0825049102

## Arborist Report

**Date:** 6-5-2020  
**To:** Tara Macdonald, Lead Gardner - Good Shepard Center  
**From:** Nicholas Johnson, OOC Arborist – Seattle Parks and Recreation  
**Subject:** Tree Assessment and Hazard Evaluation

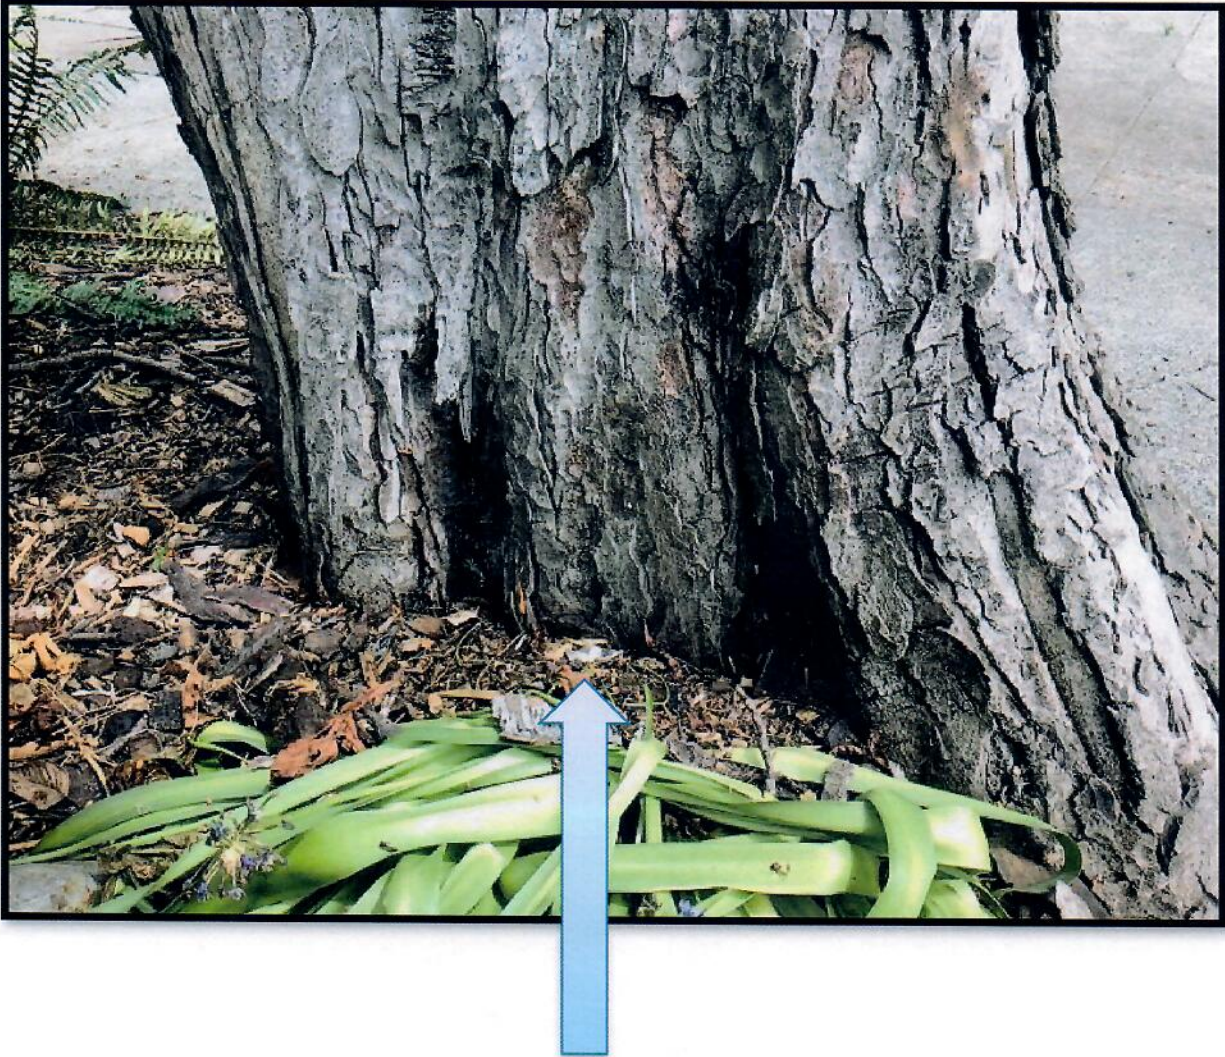
The second tree, SPR Tree Inventory # TREE - 23383 is in much the same condition, only in an earlier state of decline. I did not observe *Ganoderma* fruiting bodies at the base of this tree, but I am confident that I observed *Kretzschmaria deusta* at the stem/root interface and in a surface root. Again, it is difficult to assess the extent of structural damage that this fungus has caused but it will most likely cause this tree to fail in its entirety at some point in the future. If this tree fails in its entirety it will impact a building, possibly a second and landscaping. There is still live crown throughout this tree, although it is thin and sickly looking. This leads me to believe that there are still functional roots that are in the process of being dissolved. This tree is approximately 50 feet tall and 32 inches DBH.

The presence of *Kretzschmaria deusta* fruiting bodies coupled with visible signs of decline strongly suggests that roots of TREE - 23383 have been and will continue to become more compromised. This tree is in a moderate state of decline and detracts from the formal garden's appearance. This tree has a heavy lean towards a historic outbuilding. It is my professional my opinion this tree should be removed.

***Kretzschmaria deusta* fruiting body at the base of TREE - 23383**

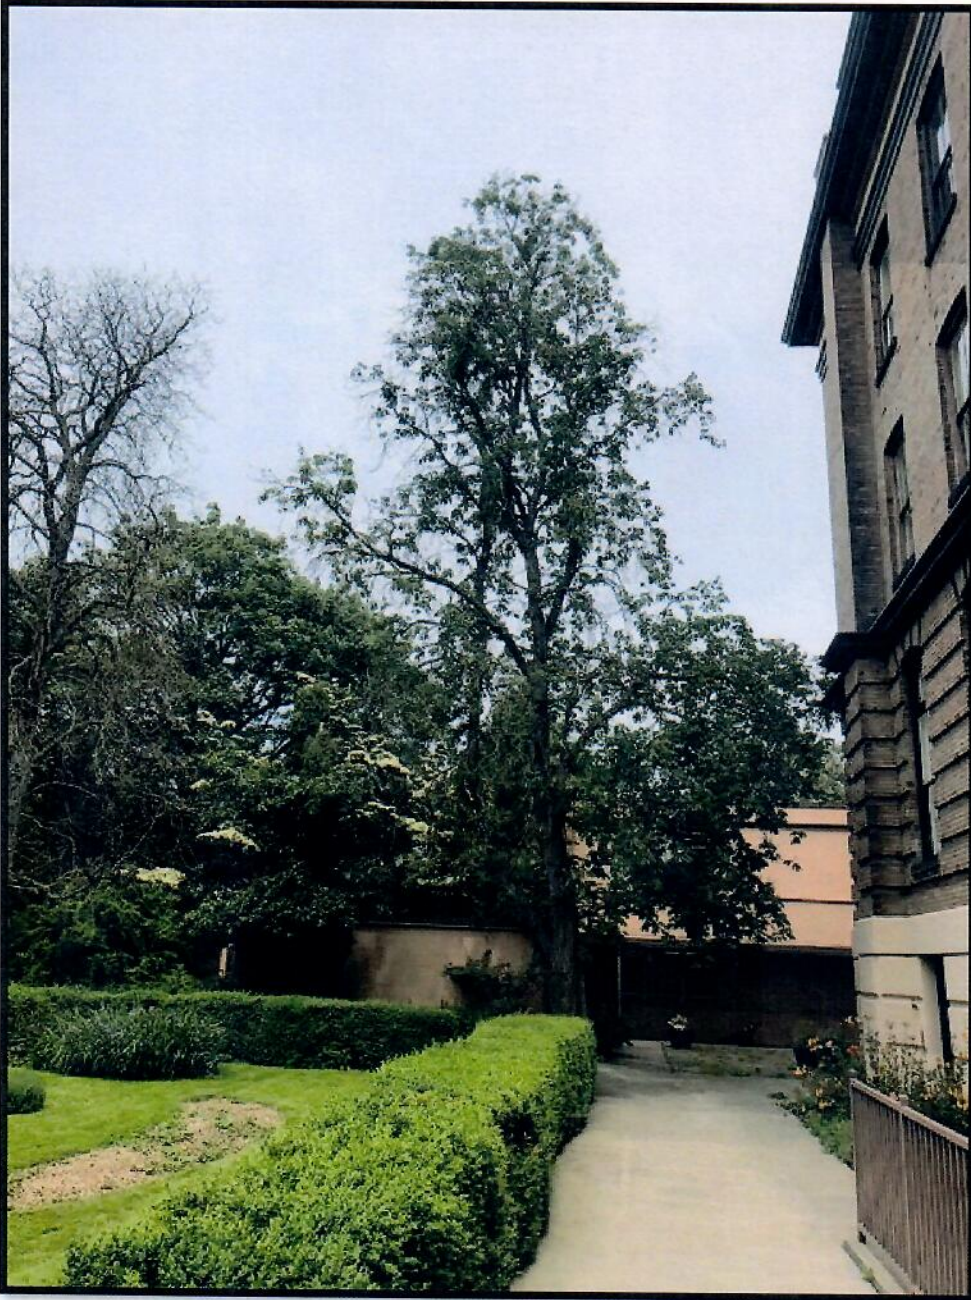
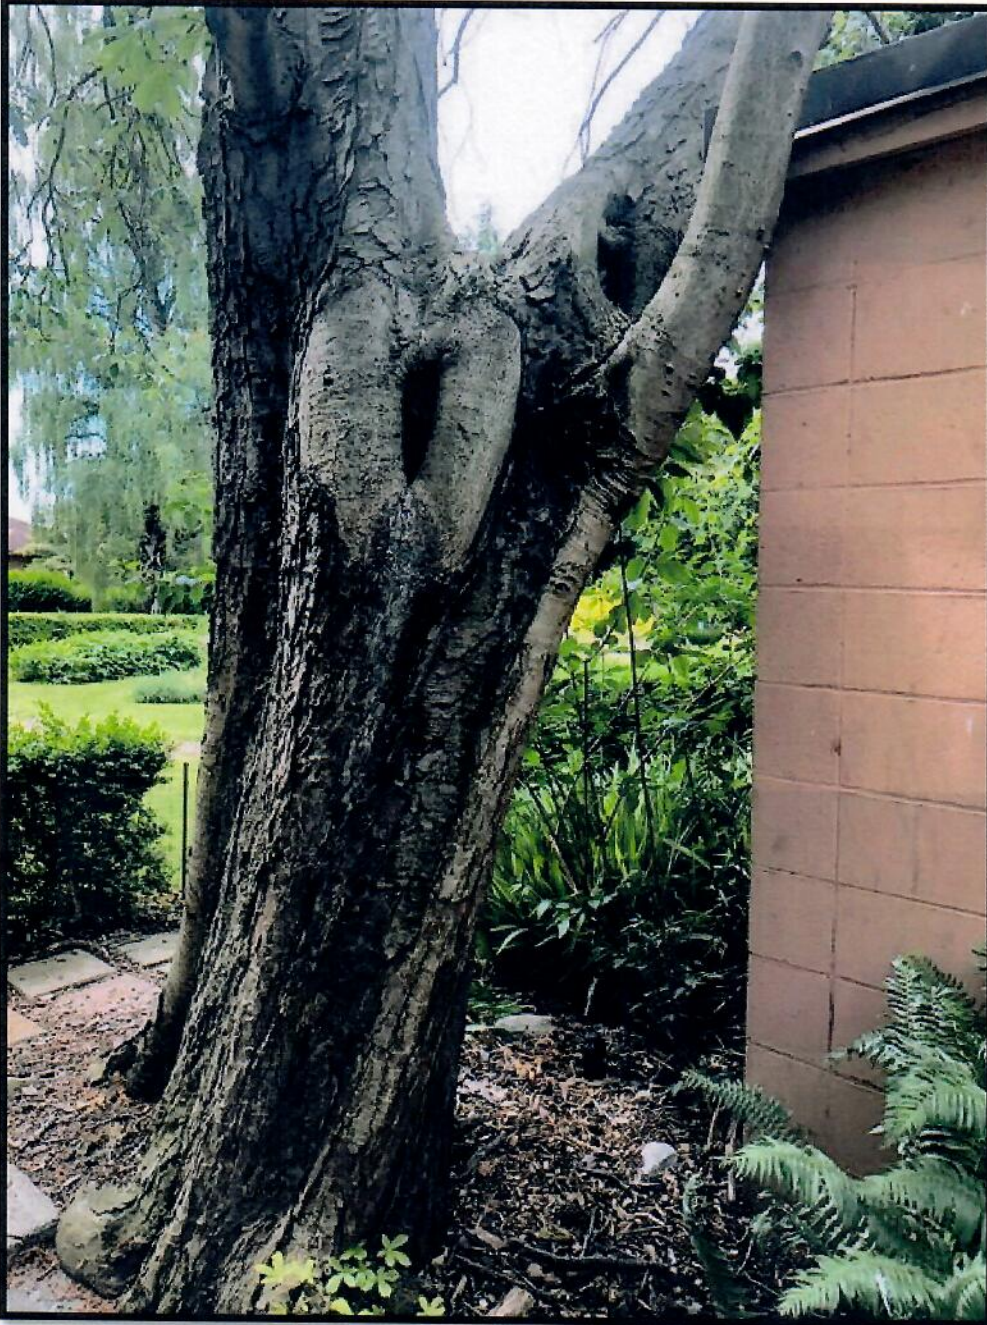
**TREE – 23383**

I evaluated tree # TREE - 23383 for risk based on an industry standard timeline of one year. I achieved a highest risk rating of moderate, utilizing the *International Society of Arboriculture's Risk Matrix* and a *Level 2 Limited Visual Inspection*. A moderate risk rating was achieved by my determination that it was possible that this tree could fail from the roots and had a high likelihood of impacting an outbuilding with significant consequences.

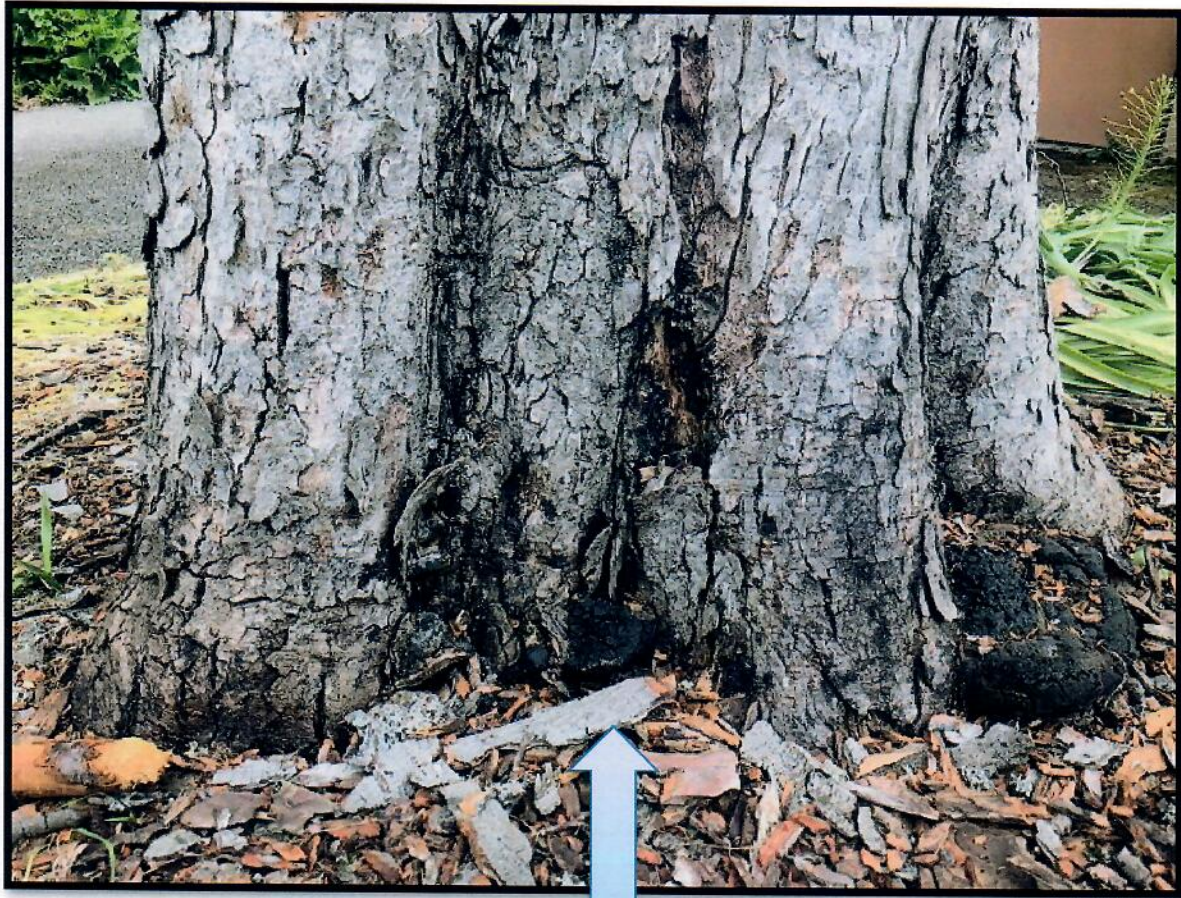
Upon arriving at the site, I first observed SPR Tree Inventory # TREE - 23382 has almost no live crown. At the base of this tree, desiccated fungal fruiting bodies were observed at the stem/root interface. I can say with a very high degree of certainty that these fungal fruiting bodies were *Kretzschmaria deusta* and some species of *Ganoderma*. It is my opinion that this tree is in a severe state of decline and its root system is structurally compromised. It is difficult to assess how much of this tree's structure has been compromised by *Kretzschmaria deusta*, my primary concern. *Kretzschmaria deusta*, is unique in its pattern of dissolving wood and confuses the instruments used to map decay in trees. The presence of this fungus and the fact the tree is almost entirely dead leads me to believe that the roots of this tree are dysfunctional/dissolved. This tree has the potential to fail in its entirety under a strong wind load within the next year. A failure of this tree could impact people, site use, a walking path, adjacent formal landscaping and a building. It is extremely difficult to predict when it will fail or what it will impact. This tree is approximately 45 feet tall and 30 inches in DBH.

The presence of *Kretzschmaria deusta* fruiting bodies coupled with visible signs of decline strongly suggests that roots of TREE - 23382 have been severely compromised. This tree is in a severe state of decline and detracts from the formal garden's appearance. It is my professional my opinion this tree should be removed.

**Kretzschmaria deusta fruiting body at the base of TREE – 23382**

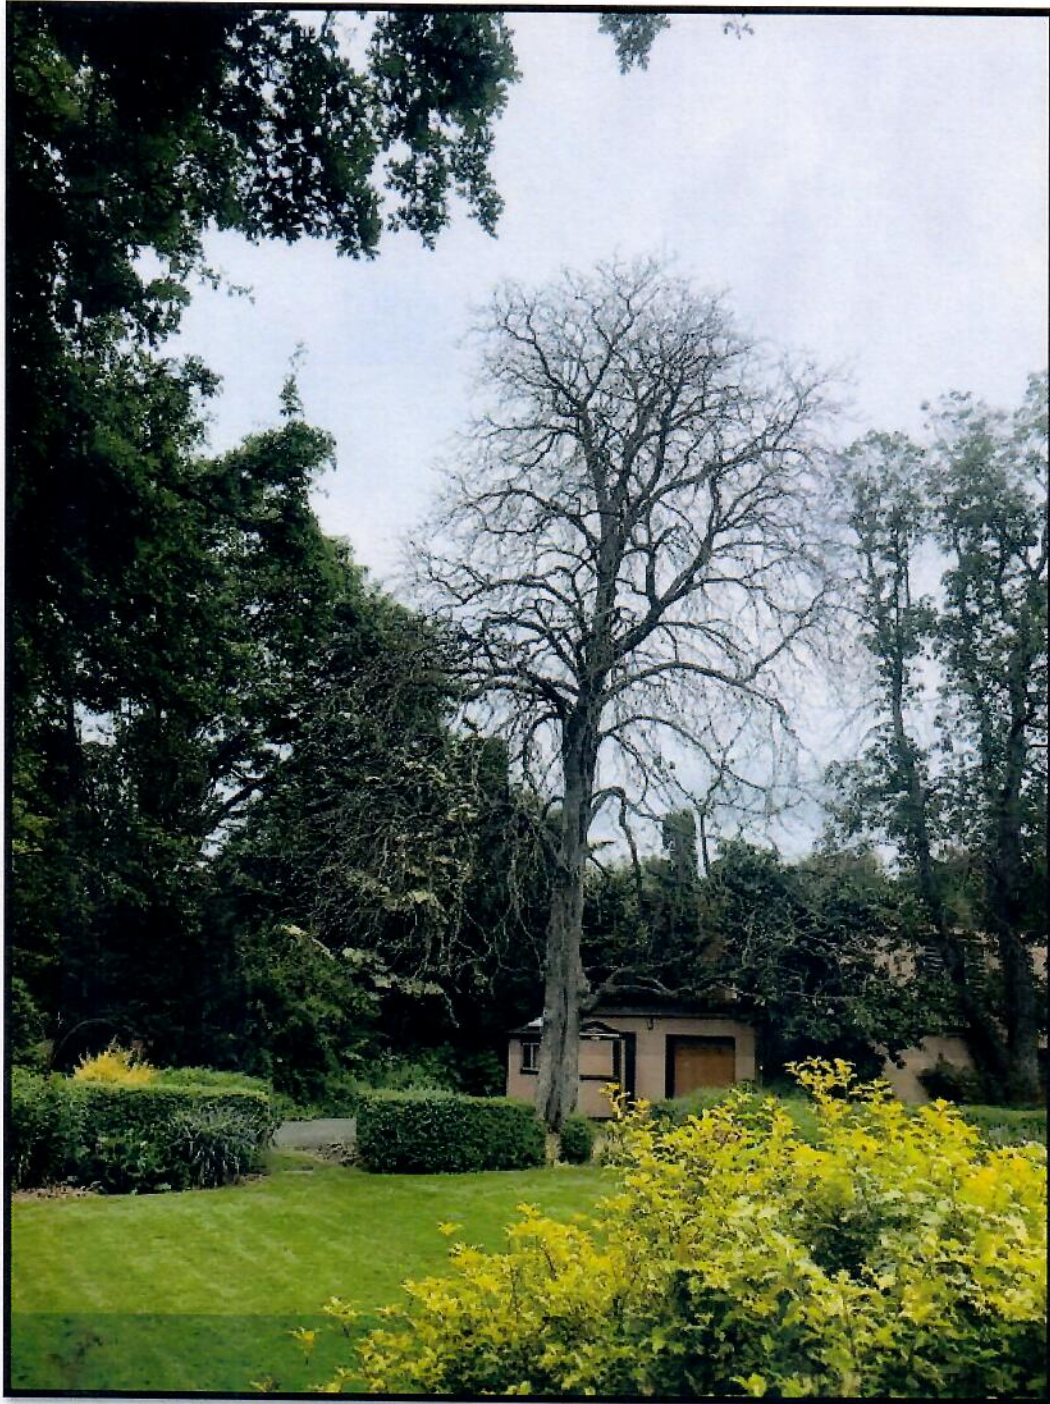
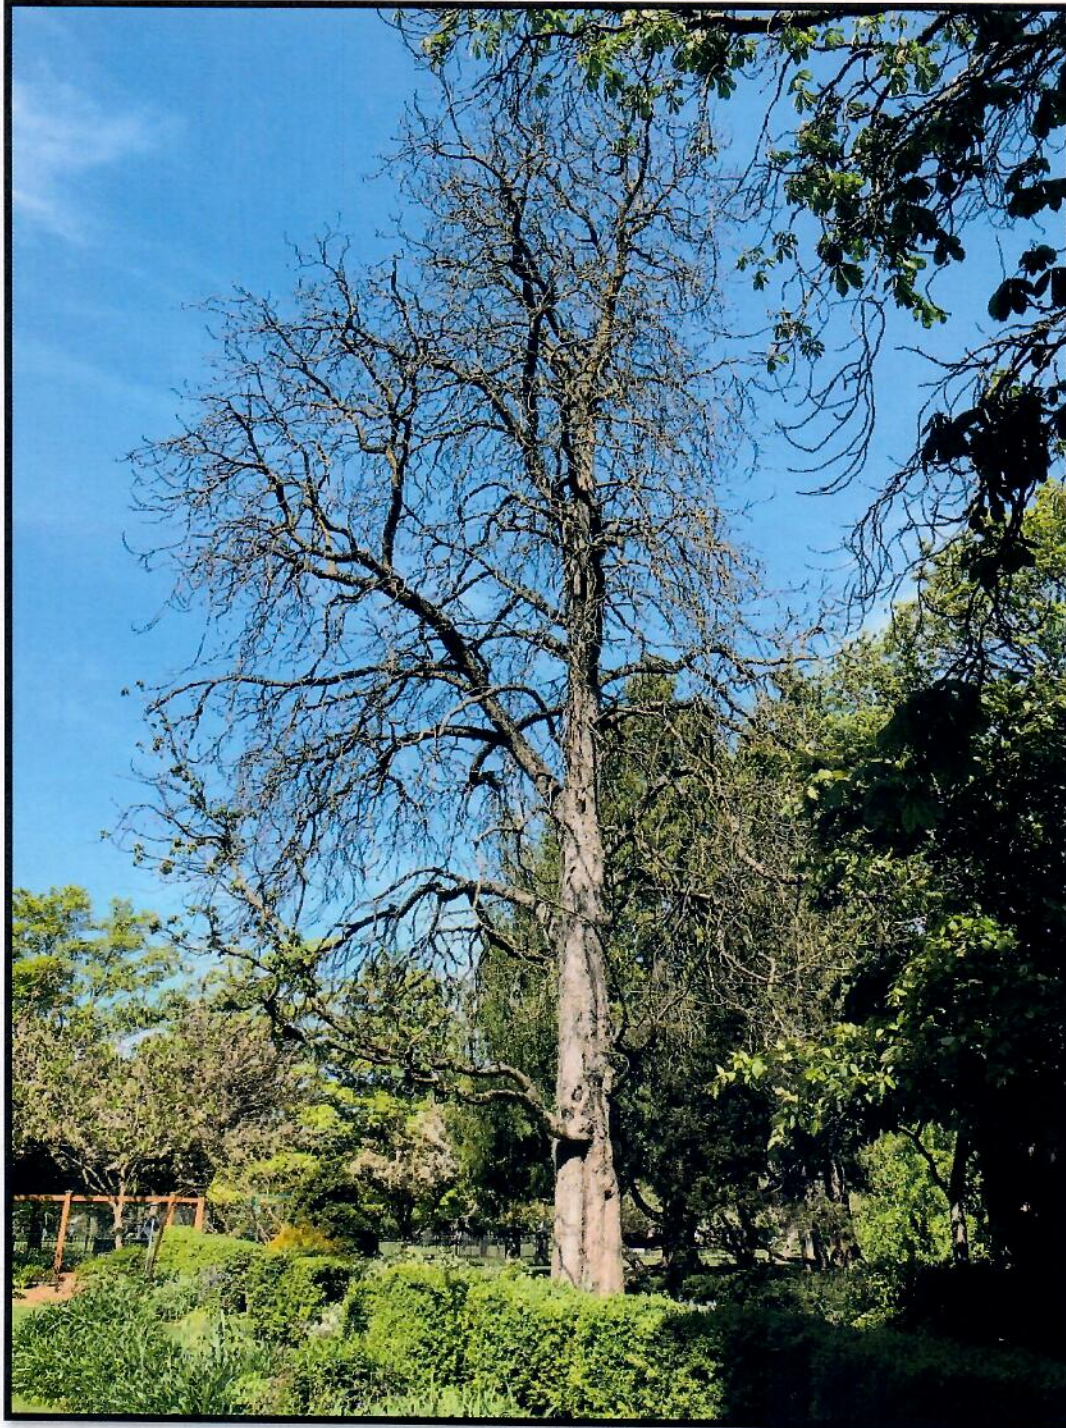
**TREE – 23382**

I evaluated tree # TREE - 23382 for risk based on an industry standard timeline of one year. I achieved a highest risk rating of moderate, utilizing the *International Society of Arboriculture's Risk Matrix* and a *Level 2 Limited Visual Inspection*. A moderate risk rating was achieved by my determination that it was possible that this tree could fail from the roots and had a high likelihood of impacting formal landscaping and disrupting site use with significant consequences.
